ARCHÆOLOGICAL SURVEY OF INDIA

ANNUAL REPORT

1923-24

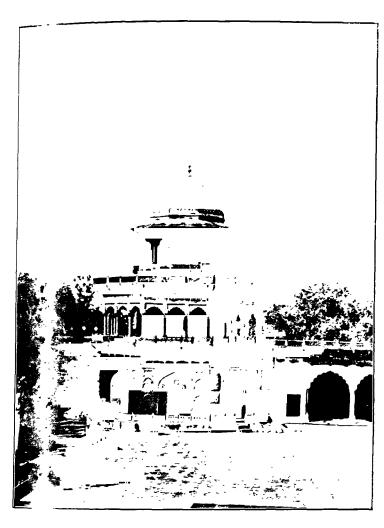
SOUTH-WEST CHATTRI AT THE TAJ. AGRA. BEFORE CONSERVATION.

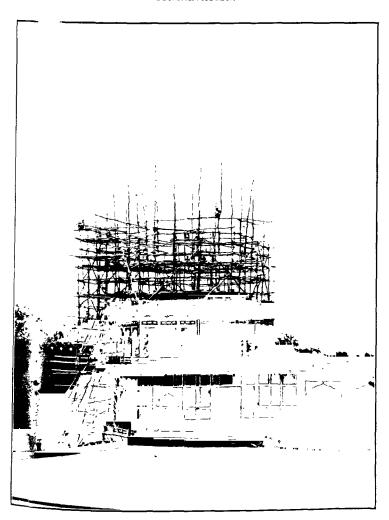
annual repairs. At Agra, the chief work was the rebuilding of the south-west United corner chhatri at the Taj. On account of cracks in its dome and the breaking Provinces of most of the lintels, brackets, capitals and bases of pillars as a result of the Muhammadan sinking of its plinth, the whole of the chhatri was in a precarious condition. Monuments As a temporary measure, three of its openings had been filled in with brick Agra masonry walls to support the most affected parts (Pl. I,a), until funds could be made available to rebuild it. In the reconstruction every care has been taken to re-use as far as possible the old serviceable stones, and with this object all the stones were numbered and photographed before dismantling (Pl. I,b). The work of dismantling and lowering the heavy stones from a height of some 80 feet was not without difficulty and danger, requiring a heavy scaffolding (Pl. I,c), strong ropes and pully blocks and the task was made all the more complex owing to the extreme care that had to be taken to avoid damage in the removal of the stones. In the course of dismantling it was found that the cupola of the chhatri was not constructed on the usual dome principles. Instead, it was built as a solid mass with exterior interior facings of marble and red sandstone respectively, the interspace between these facings being filled in with a brick masonry core. The facing stones were held in position with iron clamps and dowels, while bonding slabs fixed with iron clamps held together their respective inner and outer courses (see fig. 1).

' SOUTH-WEST CHATTRE AT THE TAG, AGRA, AFTER DISMANILING.

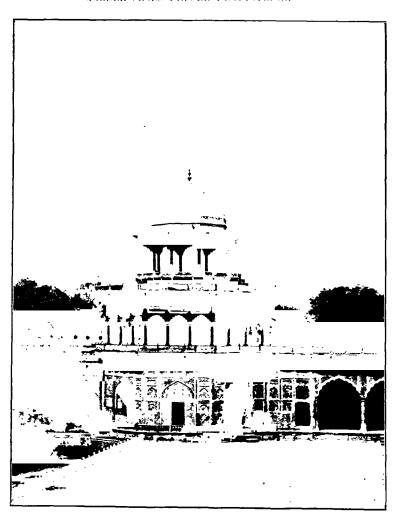
(h) South-west chattreat the Taj. Agra, showing numbering of marble slabs before dismantling.

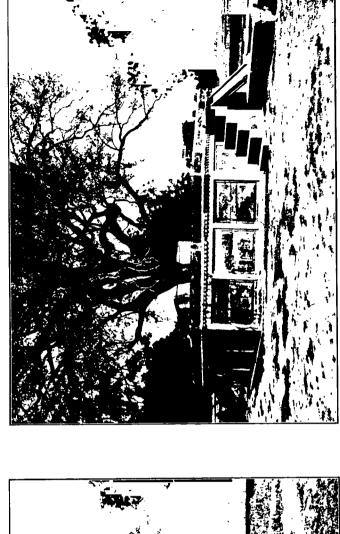
"The ruined platform of the two ancient wells near the Dak Bungalow, United The work mainly Provinces which presented a very ugly sight, have been conserved. consisted of resetting facing stone panels and copings, and replacing decayed Muhammadan and British ones (Pl. II). The provision of new teak wood doors and windows at the Dak Monuments Bungalow was another useful measure carried out during the year. the minor works executed at Sikandra may be mentioned the dismantling and rebuilding of the south quidasta in the West False gate, which had gone out of plumb, and the replacement of the broken and dislodged chhajjas, brackets and shafts in the chhatris on the second storey of Akbar's Tomb.

(a) Well near the Dar Bengalow, Sirandra, Agra, before conservation,

(a) Well near the cook house of the Dak Bengalow, after conservation,

(c) Well near the cook house of the Dak Bungalow, before conservation.

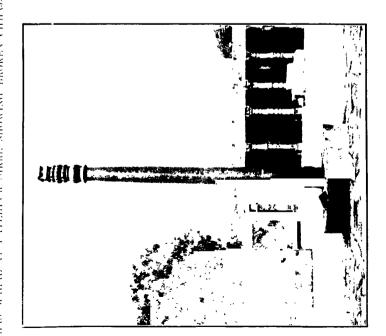
(e) IRON PILLAR AT QUIB, DELIII

(b) Anglent pillar at Kosan, after be-erection.

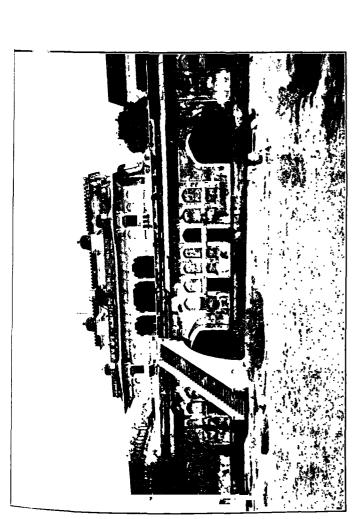
(b) SHAH ALAM RAUZA, MIMADABAD DISTRICT, VIEW SHOWING REPAIRS TO

DOMES OF THE MASHD INSIDE THE COMPOUND.

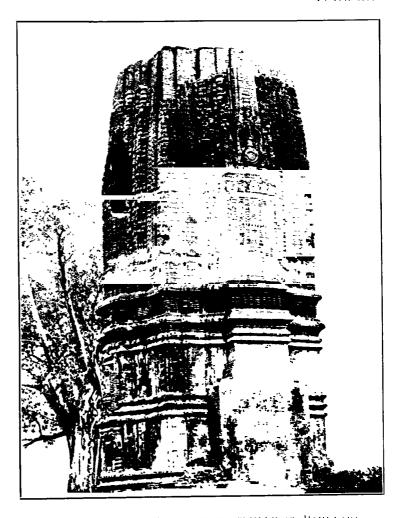
HNERAL VIEW OF SIDDHESVARA TEMPLE AT BAHULARA BEFORE CONSERVATION.

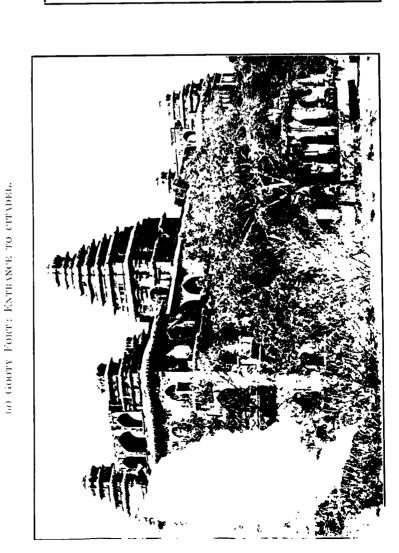
(a) THE RAIA MAIME, CHANDRAGIRE, BEFORE REPAIRS.

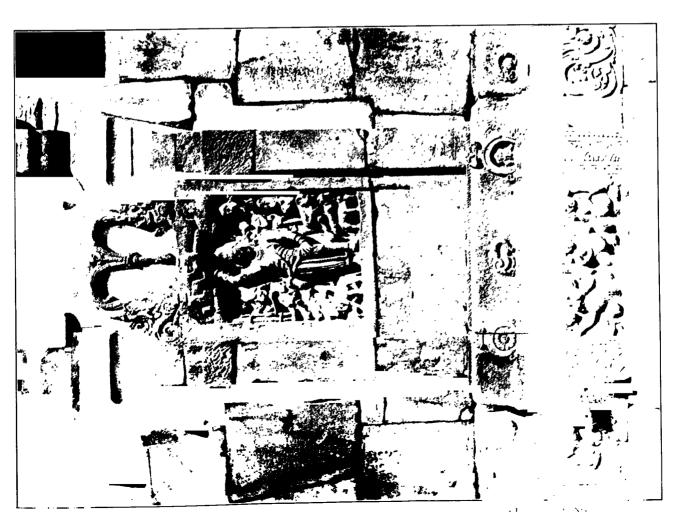
h -Hampi Reins - south east Tower in Zenana engloseria autre repairs
